NRL/MR/6180--03-8709

The Evaluation of the Autonomic Fire Suppression System Concept of Operations and PDA Cooling Effectiveness

September 30, 2003

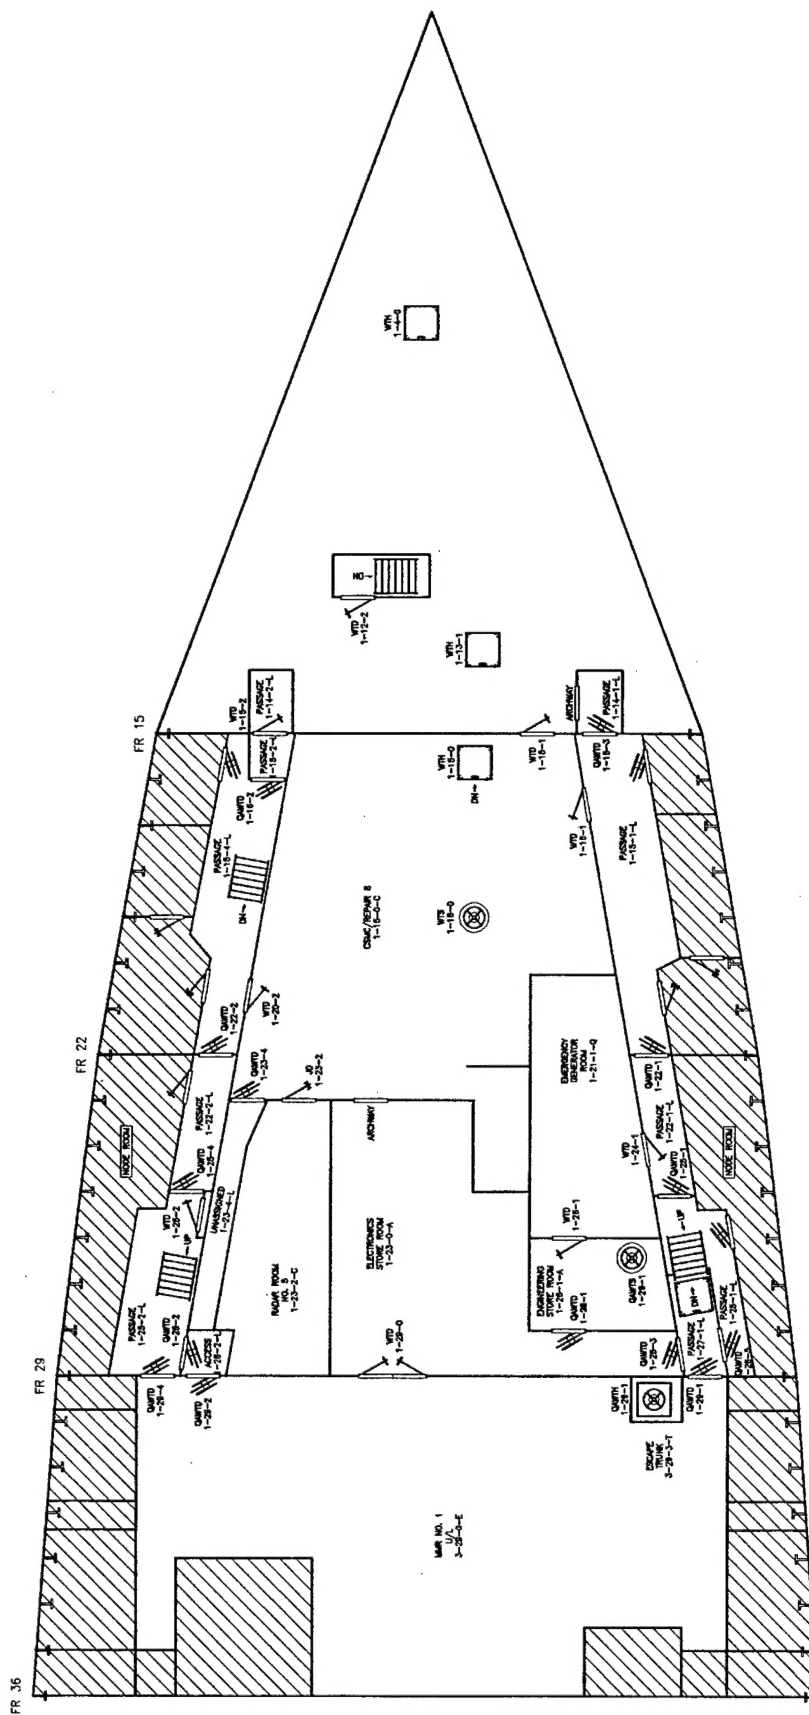
Fig. 1 - Layout of the main deck

NOTE: HATCHED AREAS ARE NOT PART OF TEST AREA.

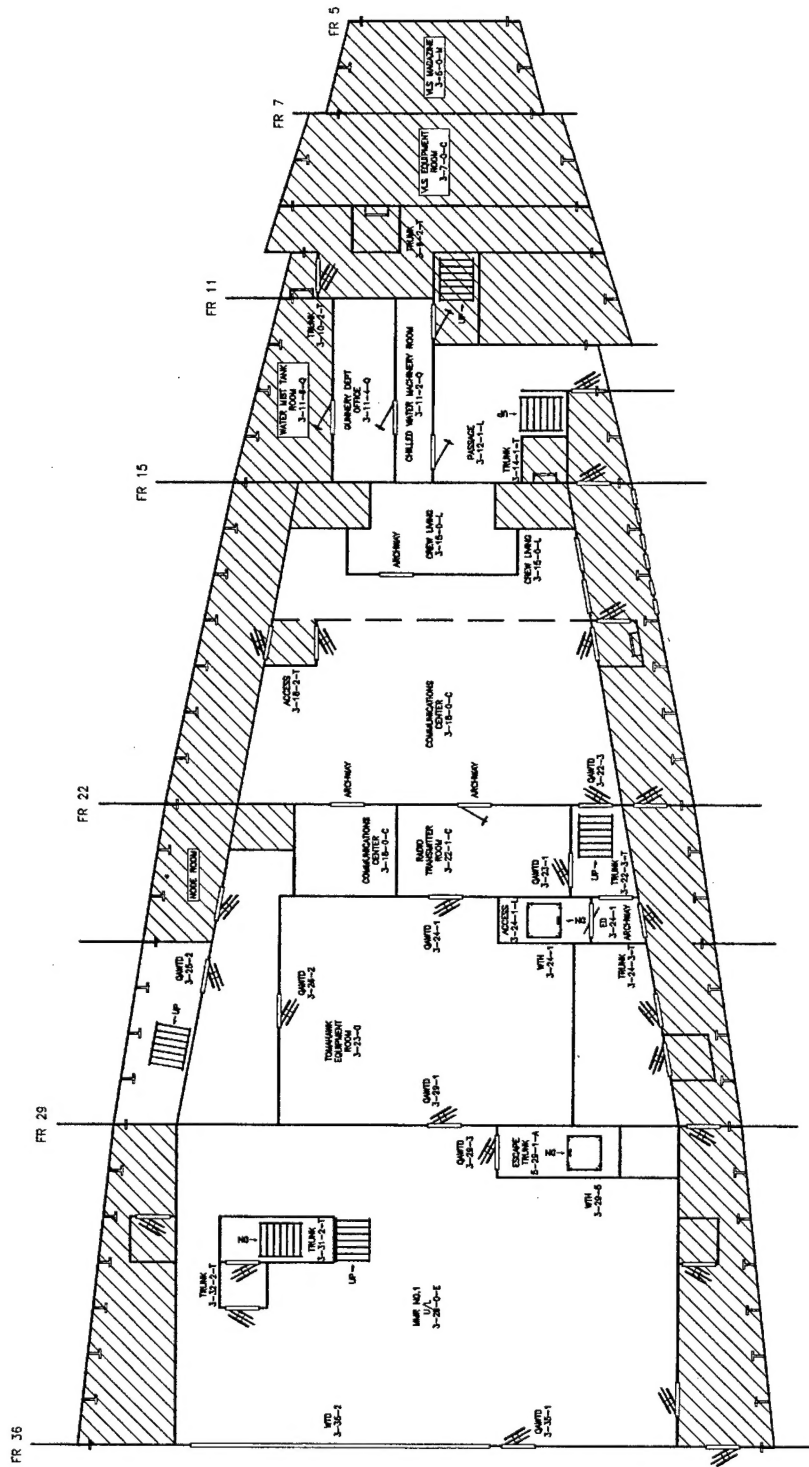
Fig. 3 - Layout of the third deck

NOTE:
HATCHED AREAS ARE NOT PART OF TEST AREA.

For the combat damage tests, damage to the PDA(F) was simulated. A large vent from the Comm Center to weather was opened on the starboard side. Internal damage was simulated by removing blast panels installed in the second and third decks. These openings provided free communication between the Comm Center and CIC/CPO Living and the Comm Center and AMR No. 1. The dashed line in Fig. 3 represents bulkheads destroyed by the blast.

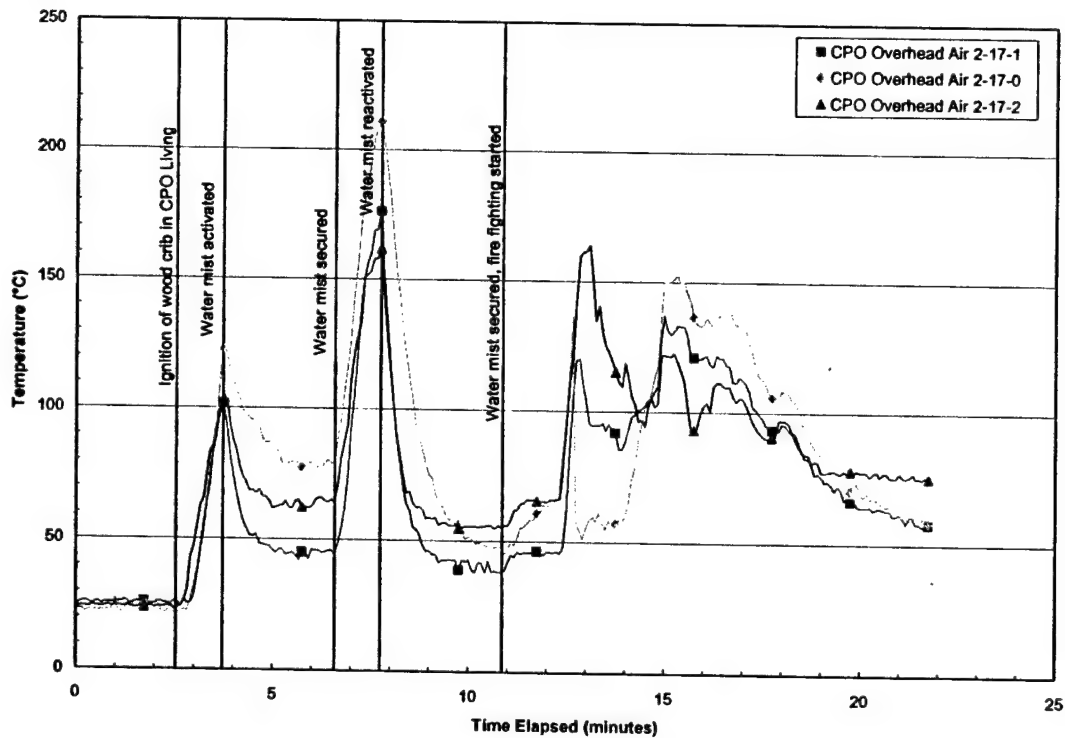
Fig. 20 – CPO Living overhead air thermocouples, afss11

The Scene Leader and Primary Responders left the 02 Level within 30 seconds of the fire being called away and arrived at CPO Living approximately 2½ minutes later. Upon their arrival, the Scene Leader requested water mist be secured so they could assess the situation. At this time, they observed the fire and decided the fire was too large for them to handle without breathing protection. They backed out of the space and waited for the Attack Team to arrive. With the water mist system secured, temperatures in the overhead quickly increased (see Fig. 20).

The Safety Team recommended that the Scene Leader reactivate water mist until the Attack Team arrived. Water mist was reactivated less than one minute later and overhead temperatures quickly dropped to approximately 50°C (122°F). The water mist system remained on until the Attack Team was on-scene and ready to enter the space.

In test afss11, the Scene Leader and Primary Responders secured water mist in order to assess the situation. As shown in Fig. 21, once water mist was secured, temperatures in the CPO Living compartment quickly increased and the team backed out of the space to wait for the Attack Team. The Safety Team recommended that the water mist system be reactivated until the Attack Team arrived to extinguish the fire. The system was reactivated and temperatures dropped. The water mist system was again secured when the Attack Team began to extinguish the fire.

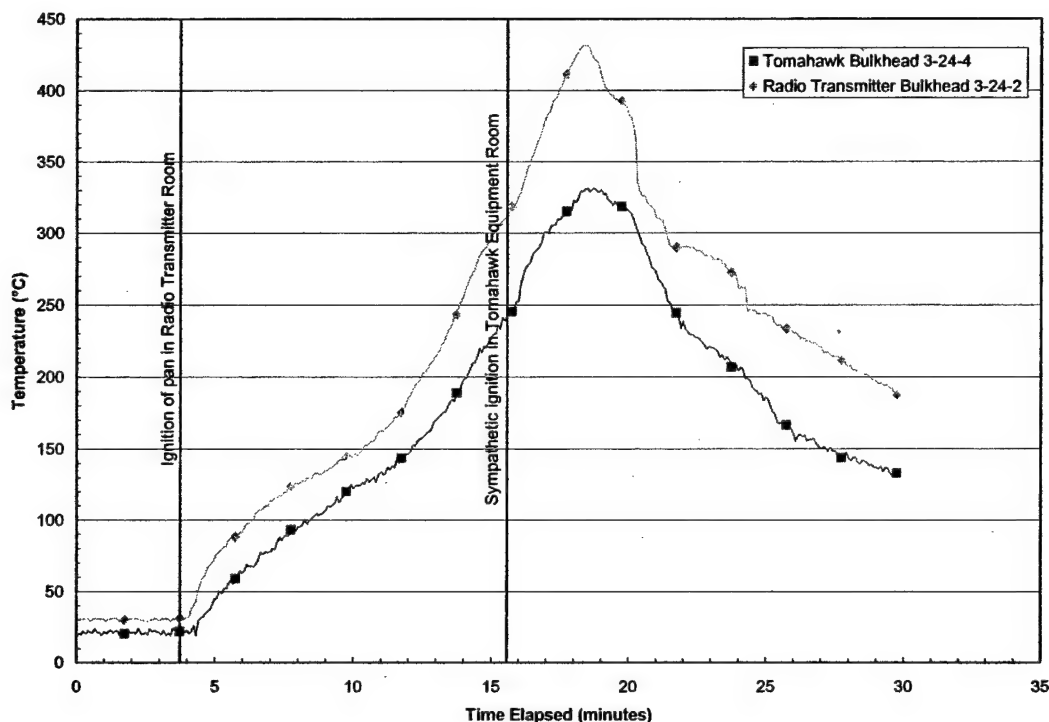
Fig. 21 – Tomahawk Equipment Room/Radio Transmitter Room bulkhead thermocouples, afss 09

Approximately 12 minutes after the fire in the Radio Transmitter Room was ignited, the bin in the Tomahawk Equipment Room ignited. At this time temperatures on the unexposed side of the bulkhead reached approximately 250°C (482°F), see Fig. 21. One minute later the bin in the Combat Systems Office ignited. The investigators continued their investigation and found a fire in the Tomahawk Equipment Room. They extinguished this fire with a portable extinguisher.

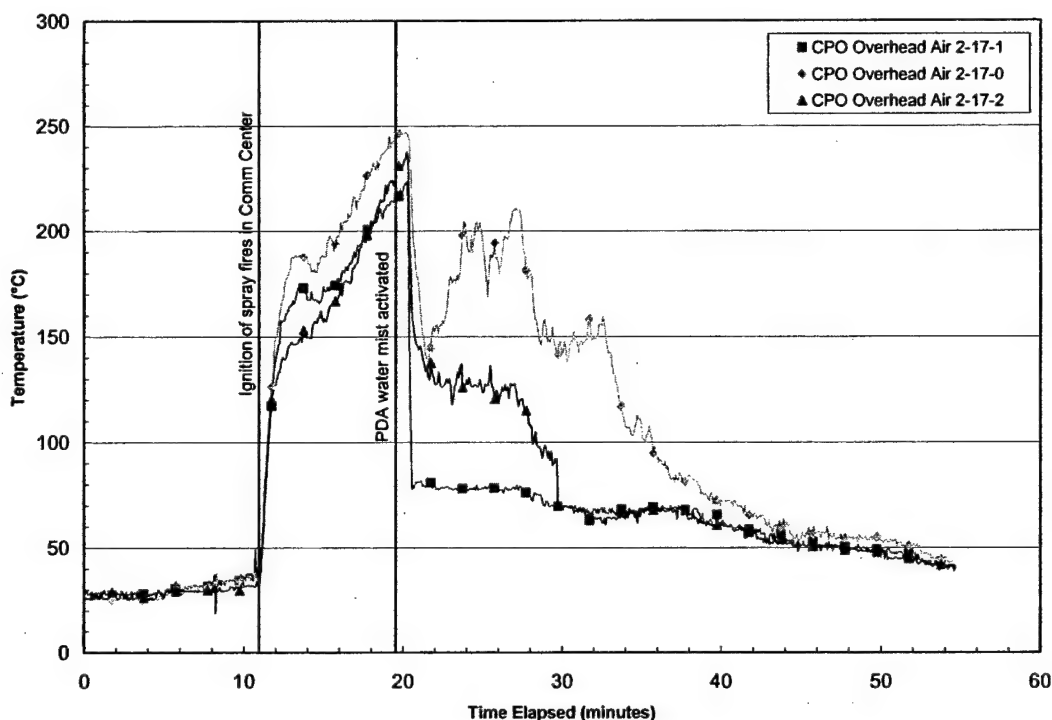
Fig. 22—CPO Living overhead air thermocouples, afss14

The PDA water mist system was activated in the CPO Living at 8 minutes, 35 seconds. With the exception of the area directly above the Comm Center wood cribs, overhead temperatures quickly decreased once water mist was activated (see Fig. 22).

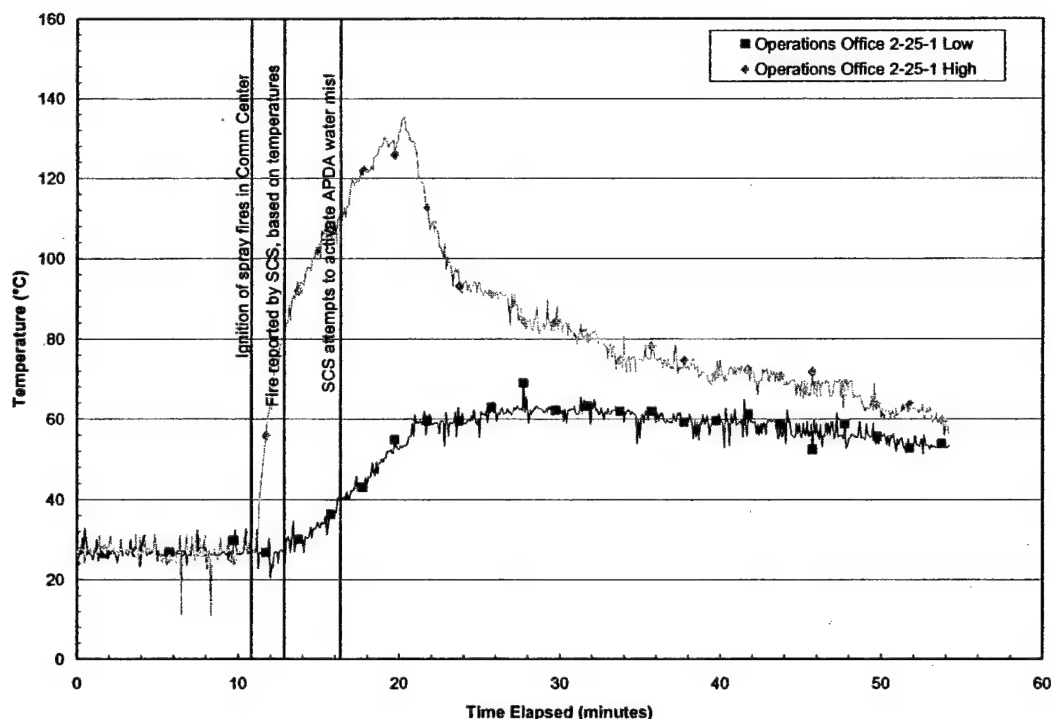
Fig. 23 – Operations Office high low thermocouples, afss15

Approximately 2 minutes after ignition of the spray fires, the SCS reported a fire in the Operations Office due to the elevated temperatures in this space (see Fig. 23). The system identified that a boundary was needed for the Operations Office. At this time, the water mist function of the supervisory control system did not appear to be functional, therefore the system was reset. After the system was reset, the SCS attempted to activate the APDA nozzles in the Operations Office (5 minutes, 31 seconds after ignition). Since this system was intended to be classified as a PDA(F) compartment, the APDA system was not operational and water mist was not activated in this space.
